# Archaeology in 2011 in the Rose Garden At Copped Hall

WEAG members' evening, February 2012 - Christina Holloway.

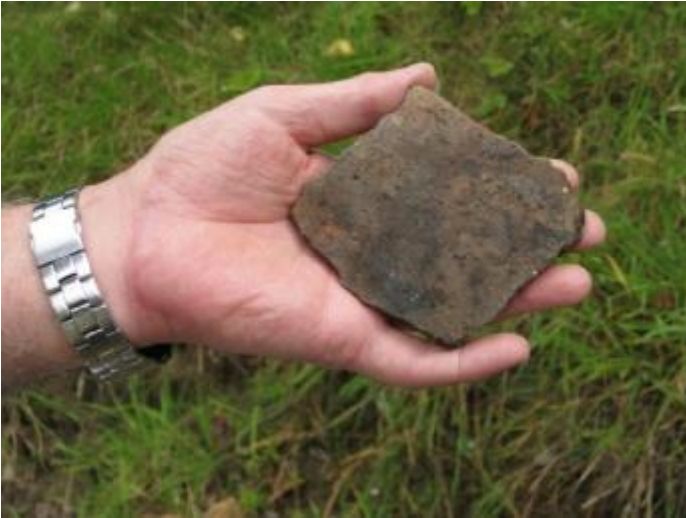
*Large piece of early-medieval or possibly late-Iron Age pottery from Trench G.*

Some parts of Trench G, particularly around the spiral stair (G310), are now over 1m lower than the surrounding paths, and it is becoming increasingly difficult to access these areas and work safely at such depths. Nevertheless, we continued removing the clay backfill to the south-east of the stair: finds are scarce in this, but it contained a large piece of pottery, either early-medieval or possibly late-Iron Age.

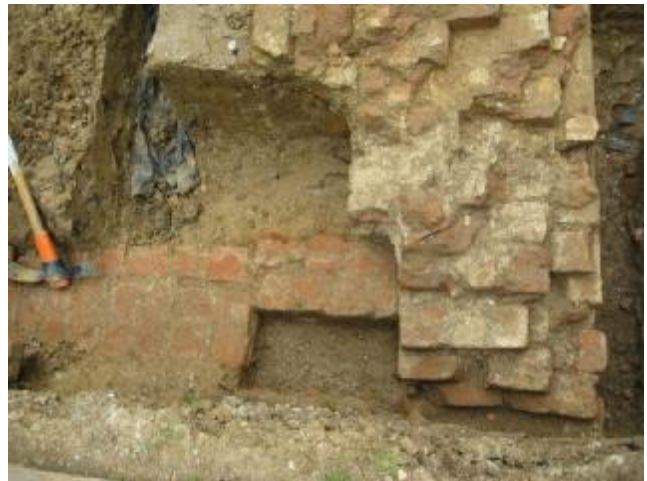
*Brick feature with possible drain.*

A brick feature (bottom left of this picture, a possible drain?) was revealed to the east of the stair, which has been severely truncated in this area. It may be possible in the future to extend the trench to the east to find out more.

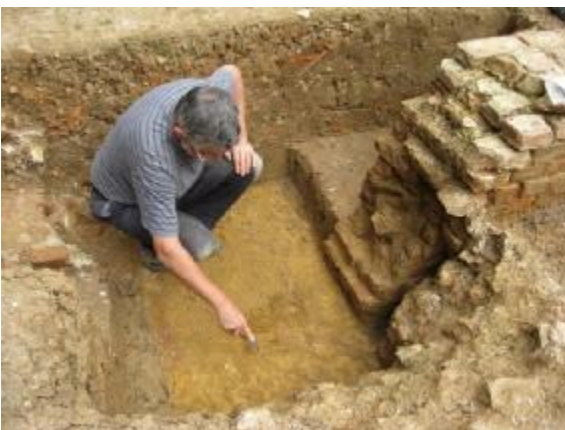
*Thick wall G444, exposed in 2012.*

G444 is shown on the left. Mysteriously, to the east of this, however, surviving to a higher level on a slightly different alignment is what appears to be a very well-compacted foundation deposit of crushed brick rubble (G422), shown below.

In 2010, we had started to explore an area near the north end of the trench, and continued to dig here in 2011. We had previously found walls G60 and G138, not shown on the 18th century plan and so possibly part of earlier building phases demolished to below ground level by that time, or possibly the remains of planned changes to the Hall which were not finished. We found that they had been truncated by the construction of the much thicker walls G444 and 445, exposed this year at low level. Their superstructure had presumably been cleanly robbed away when the Hall was demolished, but the adjacent older walls were less easily accessible.

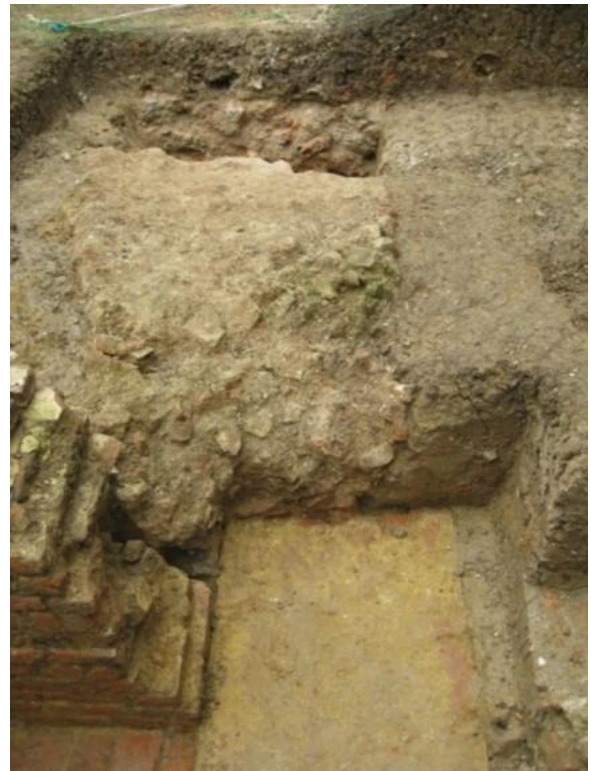
*Foundation deposit of crushed brick rubble G422.*

This is around a metre deep, and excavation of a sample of it proved to be very hard work. This year we will also explore the deposits to the north and south of it, as they may give clues to its date and the sequence of construction in this area

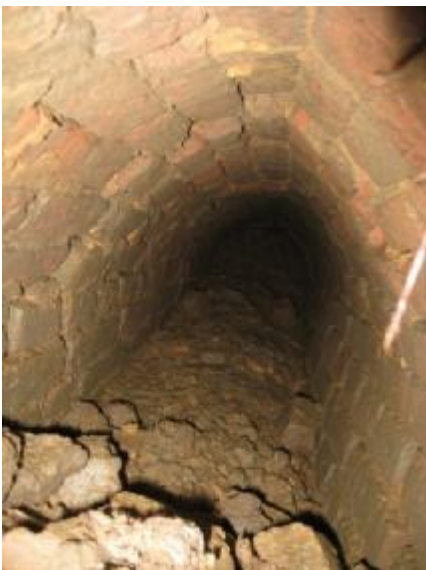
Another feature which we have yet to investigate fully is the brick culvert in the eastern edge of the trench. It is around 0.5m high, and extends for at least 1.5m to the east under the main path.

*The brick culvert in the eastern edge of Trench P.*

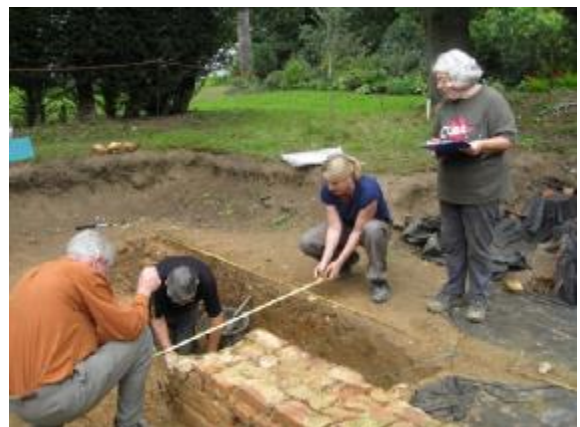
*Measuring, planning and recording a brick wall foundation in Trench P.*
