Archaeology At Copped Hall in 2012 The Taster Weekends and Field Schools

The Copped Hall Trust Archaeological Project 2012 series of Taster Weekends kicked off with the successful Spring Dig, during which a significant number of WEAG members braved the difficult weather conditions to continue the excavation and investigation of trenches G (the Rose Garden) and P (the Dovecote). This was followed by the Copped Hall Trust Archaeological Project series of three Taster Weekends in July and two 5-day Field Schools in August.

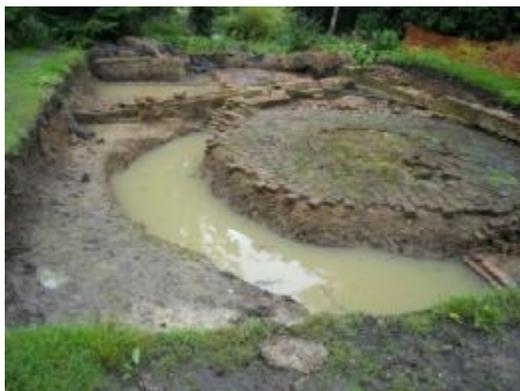
A view of the water in Trench P around the Dovecote, after the rain in June.

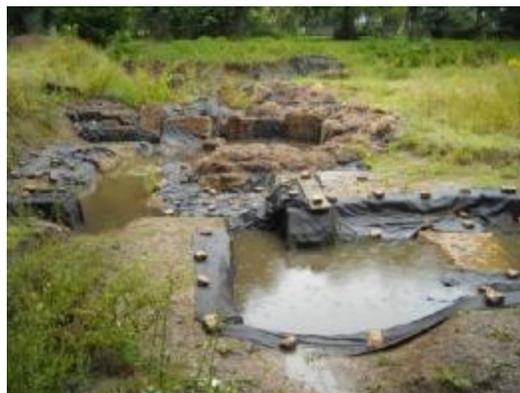
Trench G, the Rose Garden, containing the flooded foundations of the west wing.

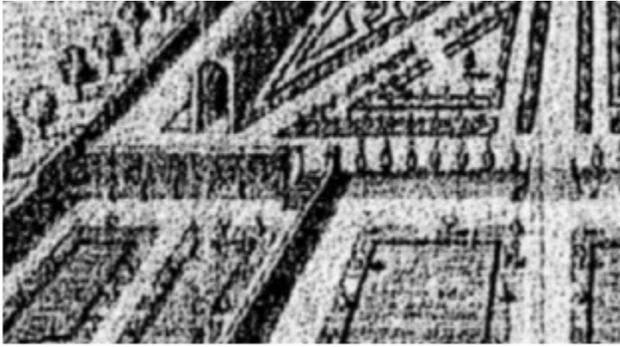
Trench R

The positioning of the larger trench was also suggested by close examination of part of the 1735 Farmer drawing of the old mansion, indicating a set of steps between the sections of garden.

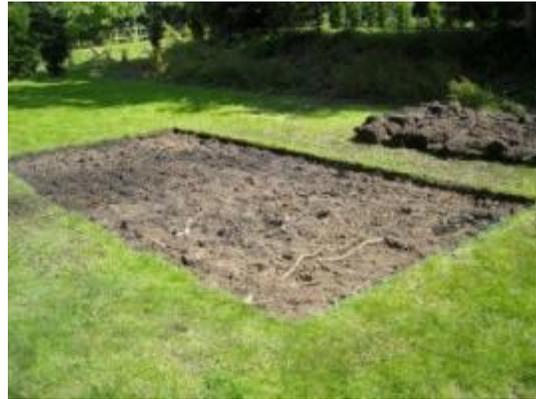
The new trench R over the possible curved foundation, ready for the start of the first Taster Weekend.

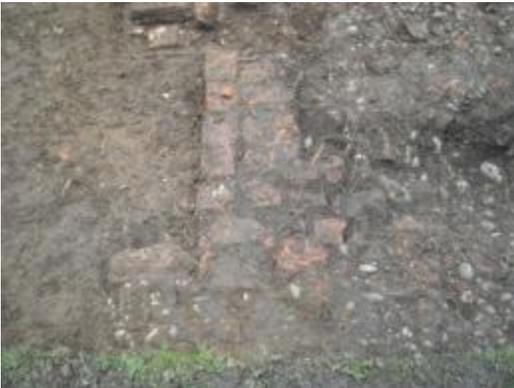
One of the North - South brick features in trench R.

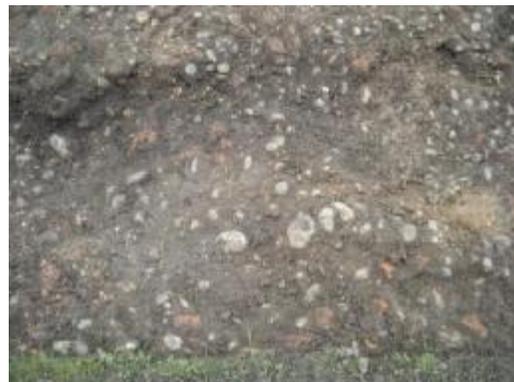
The odd depression or 'gully' in the layer of cobbles in the south of Trench R.

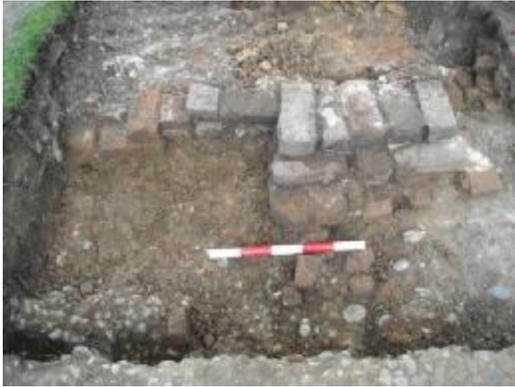
Further digging revealed a flat, compacted cobble layer between the North - South walls and the West edge of the trench - possibly part of a late garden path.

Cobble layer between the N-S walls and the West edge of trench R.

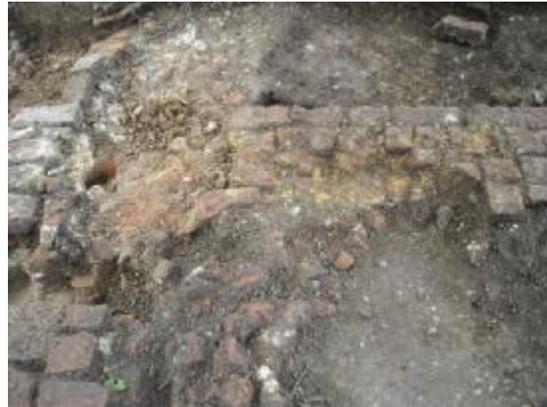
As the area to the South of the East - West brick structure was cleared, a circular depression containing soil, and partly cutting into the bricks, was found - this may have been a planting hole, similar to those found in other trenches here.

Possible planting hole cut into the brick structure.

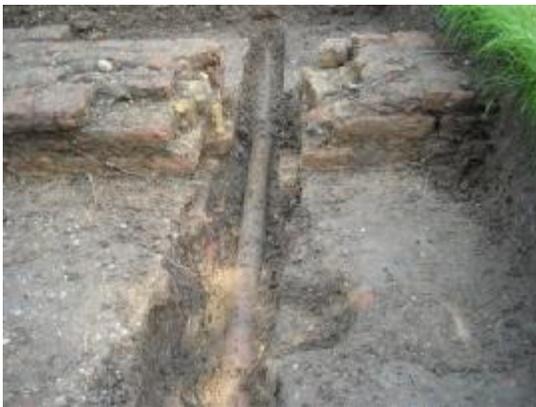
A slot had been cut into the East end of the brick structure, which revealed a land drain running North - South across the trench.

Land drain running North - South through a slot cut into the brick structure.

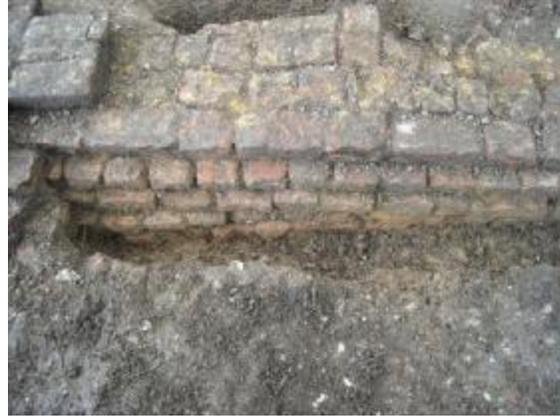
Further excavation of the North face of the brick structure showed that it was a substantial structure of at least 6 courses, suggesting a wall on top of a foundation.

Substantial structure suggesting a wall on top of a foundation.

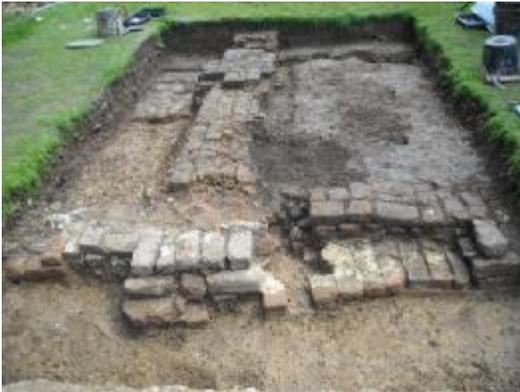
This view looking to the East across the trench shows the East - West wall with the drain at the far end. At the near end there can be seen an irregular brick structure running across the trench (this is not on the line of the garden wall that runs South from near the dovecote) that has been cut into at some time, possibly for a pipe. The structure suggest that this may have been steps, based on the partial absence of mortar on some of the bricks and the flattish surface.

Split brick structure with possible steps.

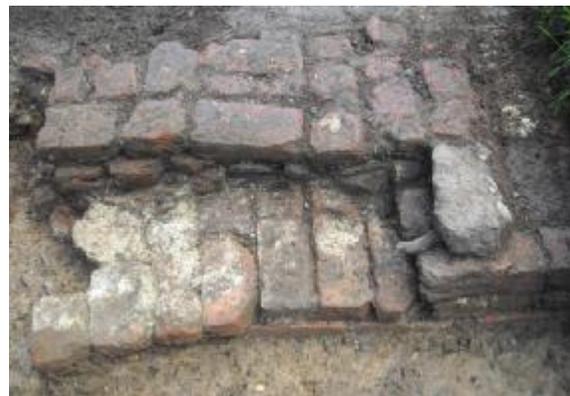
The lower, flat layer contains several shaped bricks - 2 at the extreme left and right ends have got cut-off corners, and the one in the middle of the right-hand section is rounded - these bricks have probably been re-used from earlier demolished features.

Re-used shaped bricks in the possible steps.

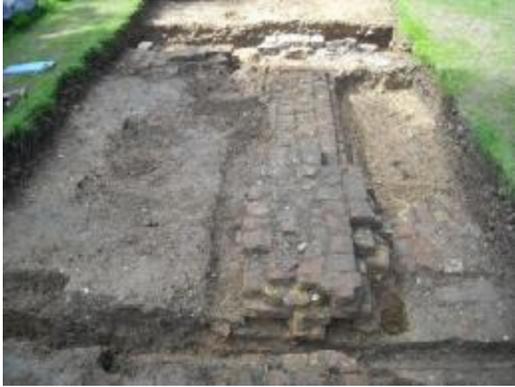
On the North side of the large East - West brick wall (the area on the right in this picture), near the drainage pipe, another section of foundation was found running to the trench edge, and next to it an area of a possible brick floor was found - however later excavation showed that this was just 2 layers of un-mortared bricks running North, possibly a wall base.

Un-mortared bricks on the right (North) of the large E-W brick feature.

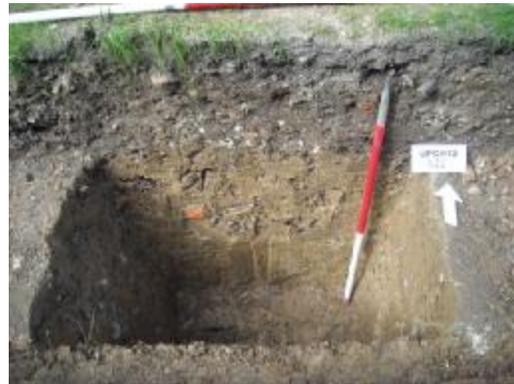
The area between the wall and the North edge of the trench appeared to be relatively undisturbed, so a slot was dug into it, revealing clean deposits of glacial and London clay.

Clean deposits of glacial and London clay.

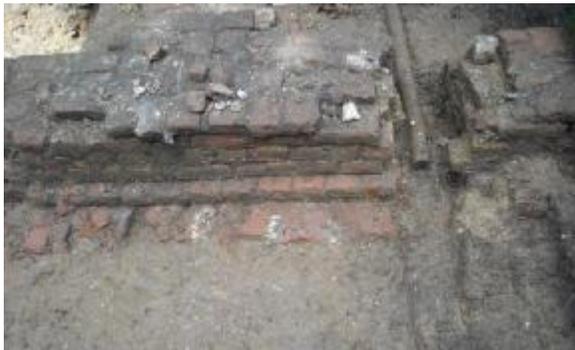
When the layer of cobbles on the South side of the wall were cleared away it revealed the remains of an irregular layer of bricks along the bottom of the wall - this may have been a floor surface.

Irregular layer of bricks that may have been a floor surface.

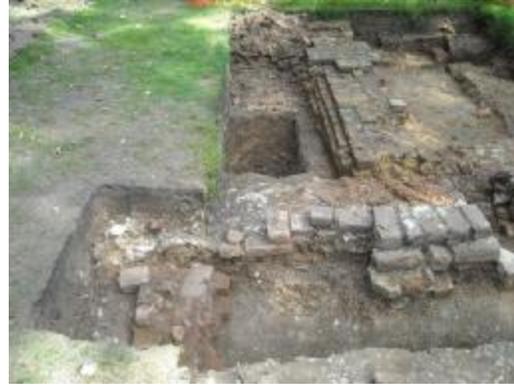
The investigation then moved to the West end of the trench, trying to track down the North - South garden wall. In the South West corner this revealed clean clay beneath the brick 'steps', with an area of grey, stony, silty material below the clay, while in the North West corner another brick structure was found.

Grey silty material and brick structure in NW corner.

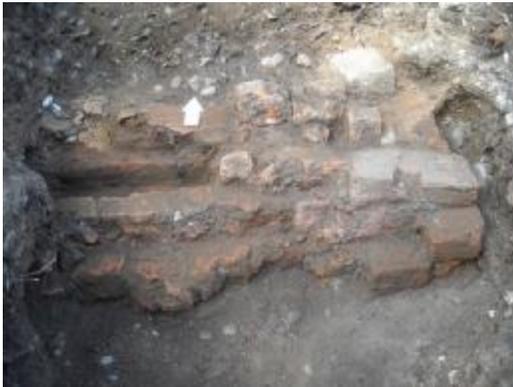
Cutting further into the side of the trench exposed what appears to be a brick drain running East - West, that has been truncated by the jumbled brick and rubble running North - South.

Truncated possible brick drain running East - West.

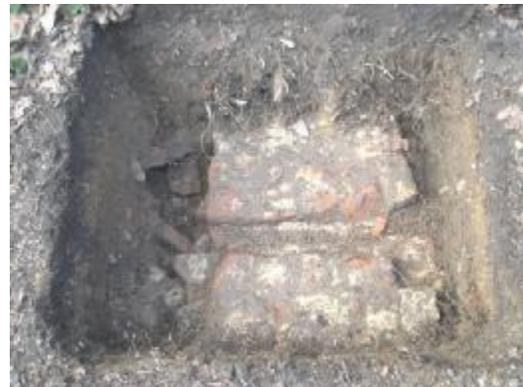
As there was no trace of the North - South garden wall in trench R, a small test pit was dug, on the line of the wall, between R and the bank to the upper lawn. This revealed the foundation of a wall, with what may be a brick drain running North West - South East beneath it. This indicates that the garden wall originally continued South towards the bank (where there may be a retaining wall between the different levels), but it was damaged by whatever was done to create the structures found in trench R.

Possible foundation of the North - South garden wall in the test pit near trench R.

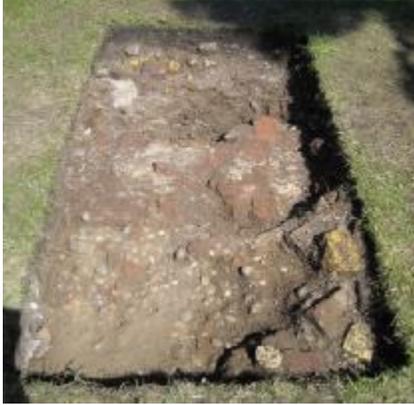
The smaller trench, S, also proved to be more complicated than expected - there was a lot of brick rubble across the trench, including broken field drains, and yellow bricks found on site for the first time. The top of the wall was found below a layer of rubble and cobbles, possibly part of a path.

A view across the smaller trench, S, showing the brick rubble and cobbles covering the garden wall.

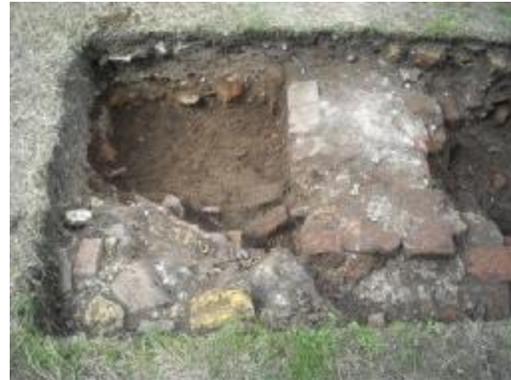
Further excavation showed a repaired break across the wall, with a rough line of bricks running to the East away from the wall - this appears to be a channel cut across the wall to allow a brick drain to be installed - curiously, there is no matching line of bricks on the other side, just a densely packed jumble of bricks.

Channel for possible brick drain across the North - South garden wall in trench S.

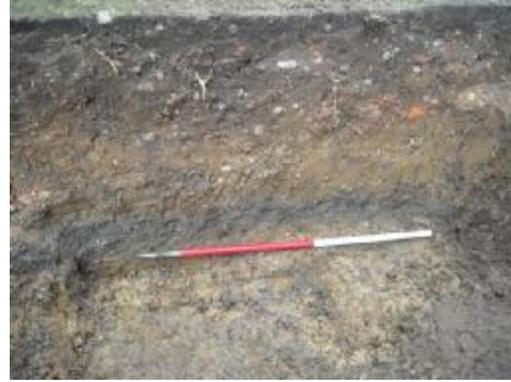
In addition to the new trenches, trench C (near the path towards the Rose-Garden) was re-opened to allow further examination of the 'grey silty layer' to see if it was linked to the similar layers found in G and P. This layer was clearly visible in the lower section of the trench below a thick layer of fairly clean clay, and could be found along the full length of the trench.

Grey silty layer visible below layers of clean clay in trench C.

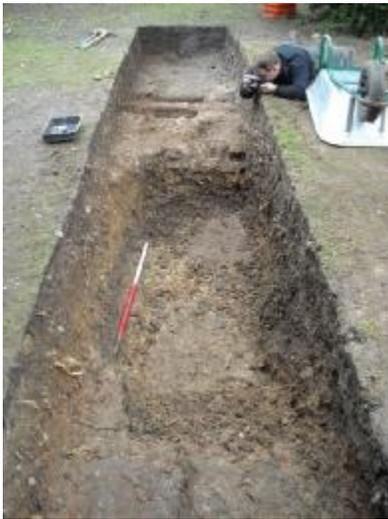
The trench was extended by about 2 metres to the South to try to find the extent of the layer, and this revealed a brick structure across the trench.

Brick structure revealed in the extended trench C.

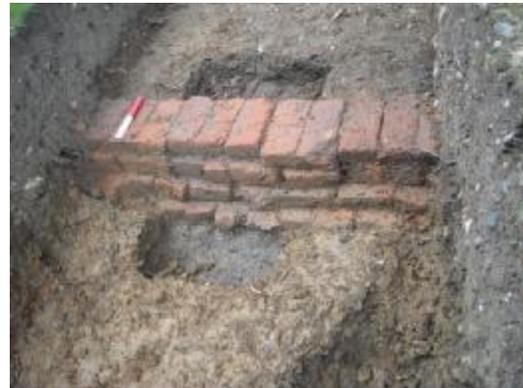
Further digging showed this to be a drain, very similar in construction to the ones running across the dovecote in trench P.

Brick drain structure running across the extended trench C.

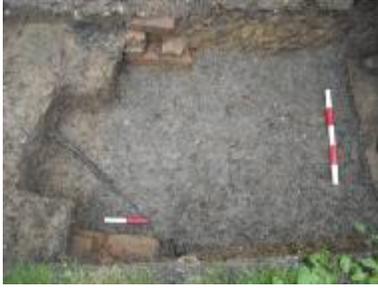
Part of the drain was lifted, revealing the grey layer running under it towards the South then stopping at the edge of the cut for the drain.

Gray layer running under the brick drain in trench C then stopping.

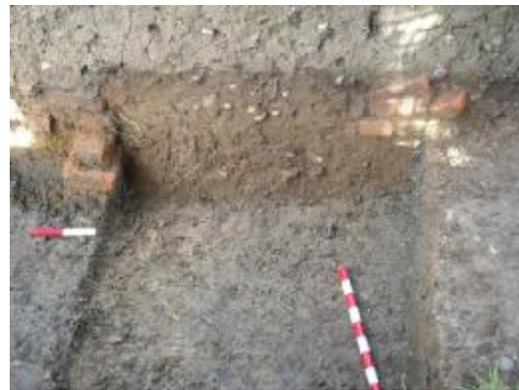
Excavating down beyond the cut for the drain eventually revealed the grey material, suggesting that the grey silt had been dug out in order to to build the drain, and then clay had been deposited behind the drain to support it. This also revealed another odd pile of bricks with no obvious structure - no purpose for this has yet been established. Levels were taken on the layers in the trench, and samples of the grey layer were extracted for examination, in order to establish if this layer matches those in the other trenches. Following this work trench C was closed down.

Gray silty layer beyond the cut for the brick drain, and additional bricks, in trench C.

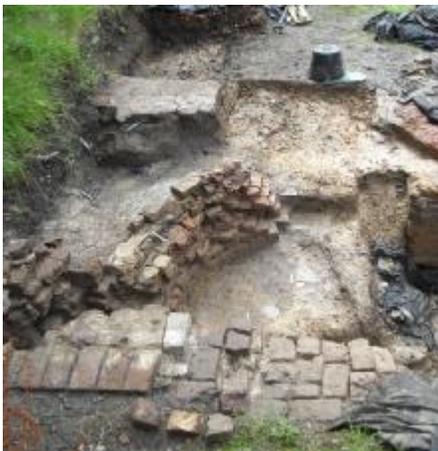
The South East corner has a mixture of curved and straight walls and a large, disturbed block of wall foundations.

Mixture of walls and foundations in the South East corner of trench G.

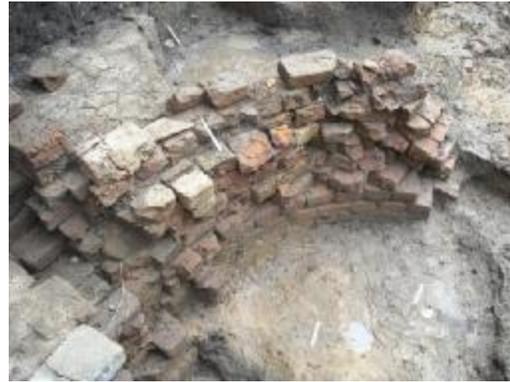
Work in this area was difficult due to the slippery clay and difference in levels, but it revealed the 'curved' wall appears to be loosely placed bricks on top of a well laid-out curved foundation, both having been truncated at some point.

Poor quality 'curved' wall on better foundation in trench G.

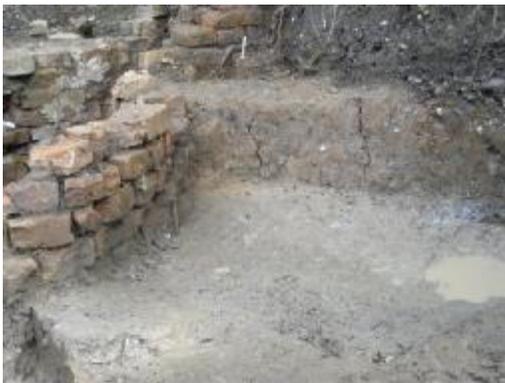
Digging outside the curved structure exposed more of the grey silty lane found in previous years, which may be linked to that found in trench C.

Grey silty layer found outside the 'curved' in the South East corner of trench G.

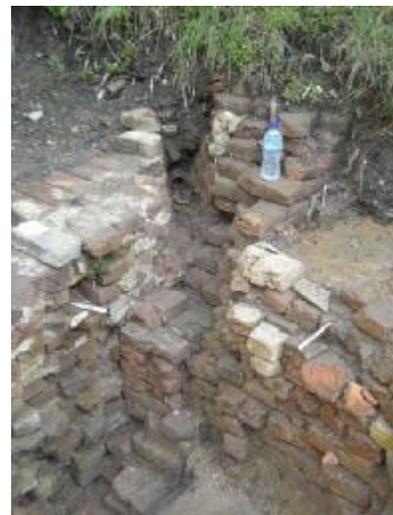
More of the adjoining brick structure in the corner was exposed, showing clearly how it consisted of multiple sets of bricks of varying sizes laid, with different coloured mortars, at various times.

Multiple sets of bricks with different mortars identified in the large block in the South - East corner of trench G.

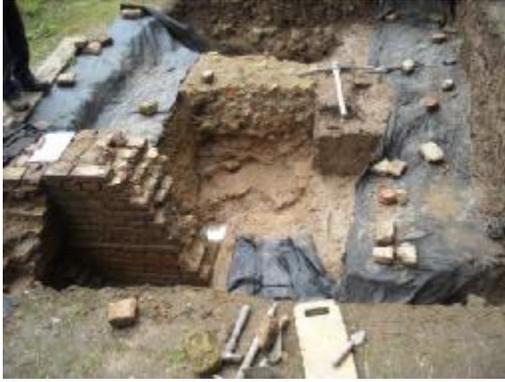
In the North - East area of the trench the material around the large mass of concreted masonry (uncovered last year) was cleared away,

Removing the material around the large mass of concreted masonry.

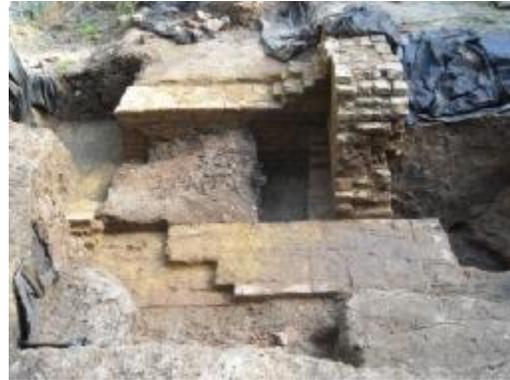
revealing a flat brick foundation with a sandy surface running East - West. This foundation was exposed further, showing that it turns and runs North - South past the other walls found in previous years. This newly exposed foundation has been useful in linking together the known walls, and it also fits well with the old plans of the mansion.

Flat brick foundation with sandy surface that runs past the other walls in trench G.

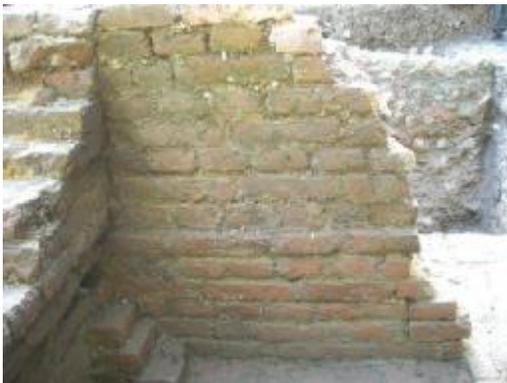
Cleaning the sides of the walls showed how the bricks in the upper and lower sections are different in size and bond, so may have been laid at different times.

Cleaned-up walls showing the variations in brick sizes and bonding.

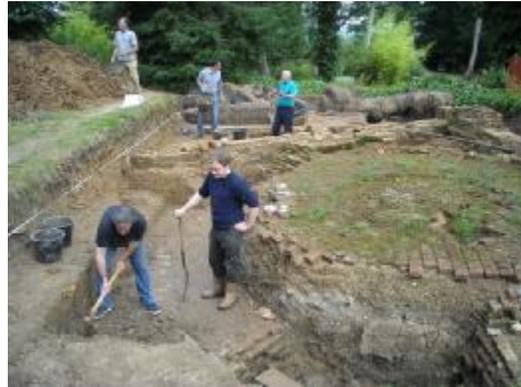
View looking north across trench P showing the Dovecote, the layers beneath it, various brick features and the South - East corner of the old mansion.

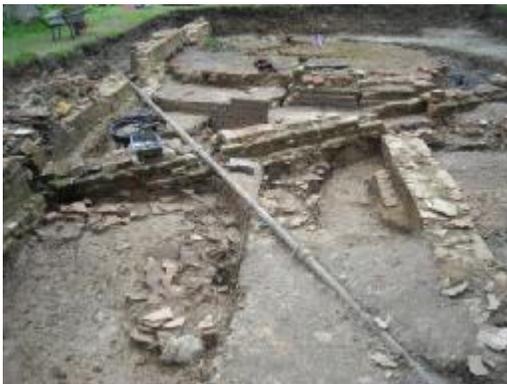
Despite the occasional poor weather (particularly during the Spring Dig), good progress was made in excavating the multiple layers of tiles across the Northern part of the trench, with at least 4 separate layers being identified. It is possible that these tiles were laid on the surface of the clay at various times to provide a reasonably safe surface to walk on and reduce the risk of slipping.

View across the trench looking South showing the multiple layers of scattered tiles.

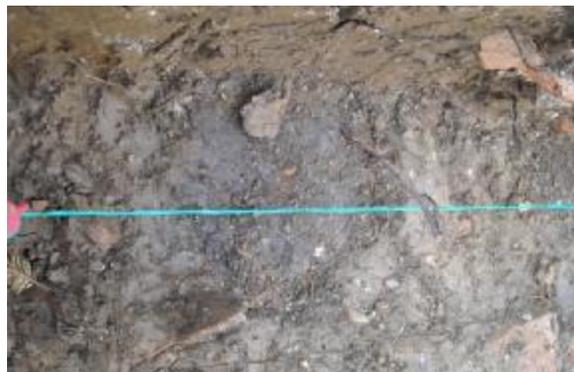
In the middle of the tile area a small, round, dark area of material was found that may have been a post-hole - the only one found so far.

Round dark feature, possibly a post hole, found in trench P.

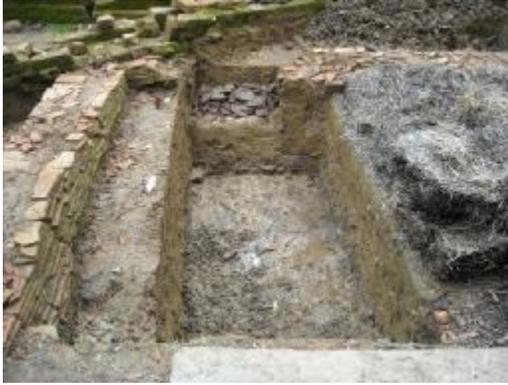
A series of three linked 'walls' of piled up tiles was uncovered on the West side of the trench (two of them running into the side of the trench) - they may have formed the retaining sides of a water feature, possibly to handle the rain water from the roof of the dovecote and the mansion. A section was dug in the base of this feature to compare the clay here with the layers found around the rest of the trench.

Two of the three tile 'walls' possibly enclosing a water feature to handle rain water from the roof of the mansion.

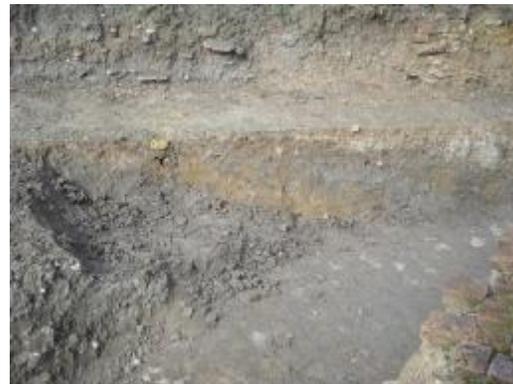
Below the floor of the dovecote, and on the West and South sides of it, there are sloping layers of grey and orange clays, indicating that the building of the dovecote was preceded by the back-filling of an earlier excavation.

Sloping layers of grey and orange clay back-filling a trench that pre-dates the Dovecote.

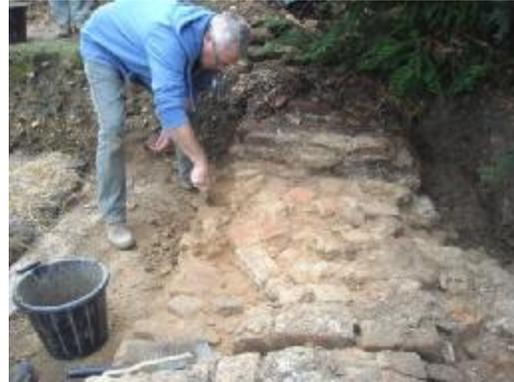
In the North - West of the trench is a small section of the foundation of the South - East corner of the old mansion. The work this year revealed this to be a complex structure, with a straight-sided base and angular upper layers, and additional courses added roughly at one end. Understanding how this fits the known plan of the house will require further investigation.

Part of the foundation of the South - East corner of the mansion.
