The 2010 season at Copped Hall

Copped Hall Trust Archaeological Project, Essex:
Trenches excavated 2002–2010

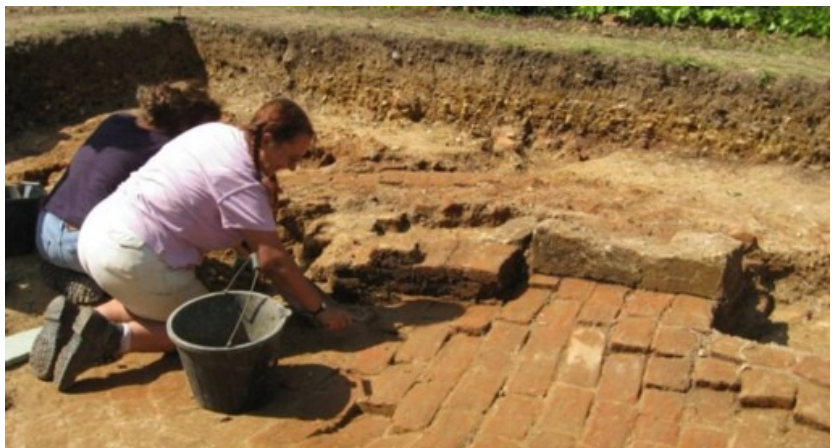
Cleaning the brick platform, with the stone step of the dovecote on the right

During the WEAG excavation week, the northern third of the trench was worked on, together with an area on the eastern side of the garden wall: the latter revealed that the wall foundations continued at the same level under the garden wall and around the brick platform. In the north-east corner, more of a (Victorian?) water pipe was exposed, cutting through the garden wall and extending to the north edge of the trench. An additional small brick block was found on the east side of the wall at the north trench boundary, possibly a base for a gardener's dipping bowl. Removal of the remaining deposits over the northern part of the platform revealed a rectangular stone block, its inner edge set back from the brick slightly: the foundations on each side of it become narrower and there appears to be a stone base for a vertical frame on one side (the other has been robbed away). This suggests that the block was the step for a doorway into the round 'building', which now seems fairly certain to have been a dovecote.

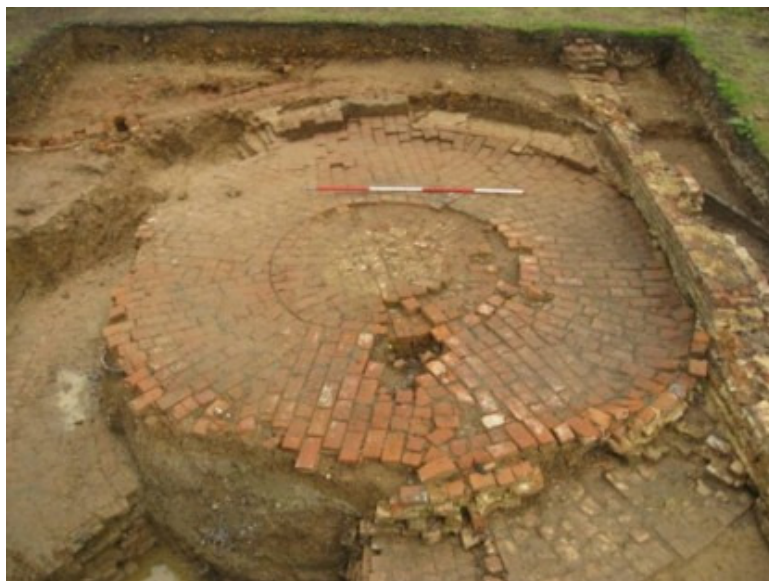
Trench P at the end of the WEAG week: the brick platform from the south

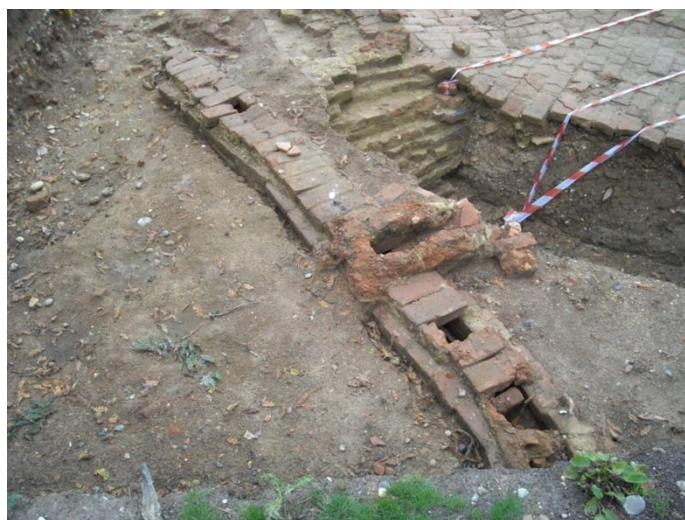
View of ‘drain’ structure looking east from the north end of the western trench edge

- One running east about 1m from the west edge of the trench and then turning south above the wall foundation – this proved to simply be a line of bricks placed in a ‘dog-leg’ on the surface, with no clear function.
- The second, lying next to the first one at its west end but then running north-east to the north edge of the trench, outside the line of the wall foundation. It has at least three mortared layers of bricks in two parallel rows, with closely-fitted bricks laid across the top. In addition there is a ‘socket’ built from carefully placed tiles part-way along – this appears to be an inlet for a downspout, suggesting that the structure may be a drain for rainwater run-off.

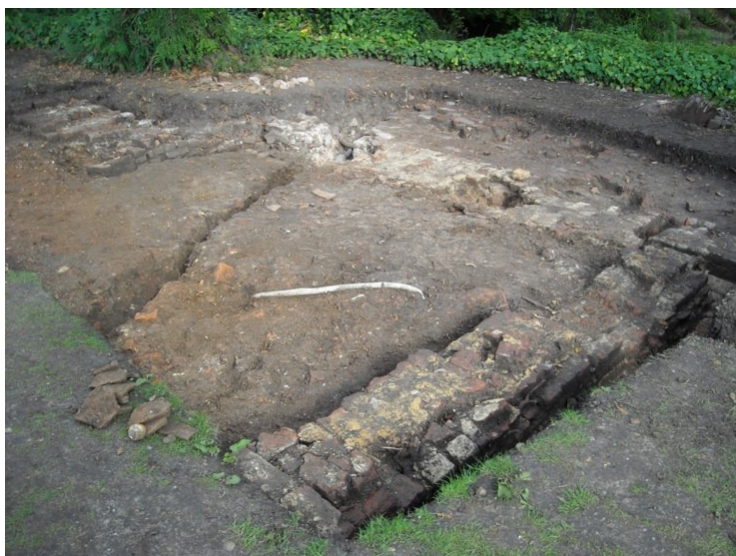
General view of the Trench P extension, looking north-west, showing the garden wall in the foreground, the south-east wall of the Hall in the top left corner, with the 'new' wall running from the Hall to the garden wall, and the brick surface beyond it. Note the lead pipe visible in the centre.

As expected from the plan, the wall of the hall is very wide (4ft or 1.2m). The west-east wall is also substantial (3ft or 0.9m) with a levelled course of bricks on a rubble base, suggesting it was more than just another garden wall. The brick floor behind it is also well built, consisting of closely laid bricks on a deep rubble base. It was clearly in use for some time, as it has been repaired in a number of places with later stock bricks. Both the brick floor and the west-east wall have been cut into in several places creating a number of round(ish) holes, possibly for the purpose of planting shrubs. On the south edge of the west-east wall is a layer of tiles – most appear to be roughly deposited, but at the west end there is an area where they have been piled up, possibly for the purpose of levelling.

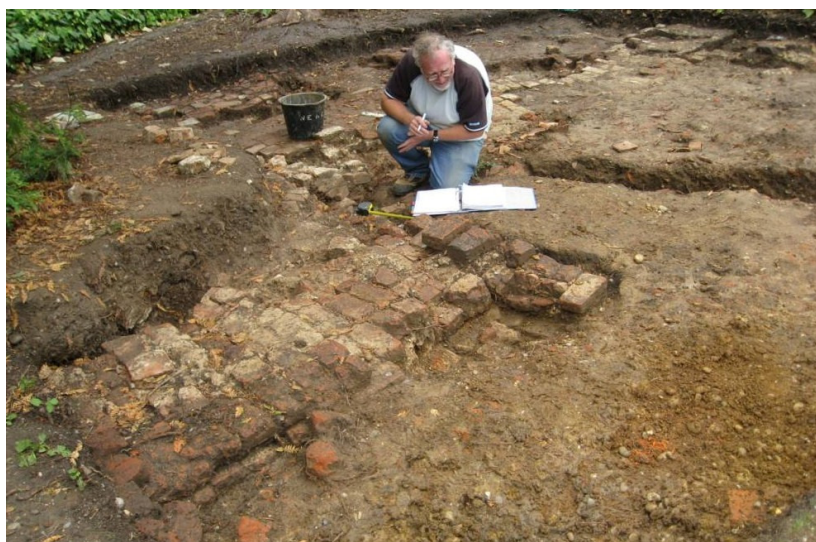
The Trench P extension, showing in the centre of the picture the south-east corner of the Tudor Copped Hall

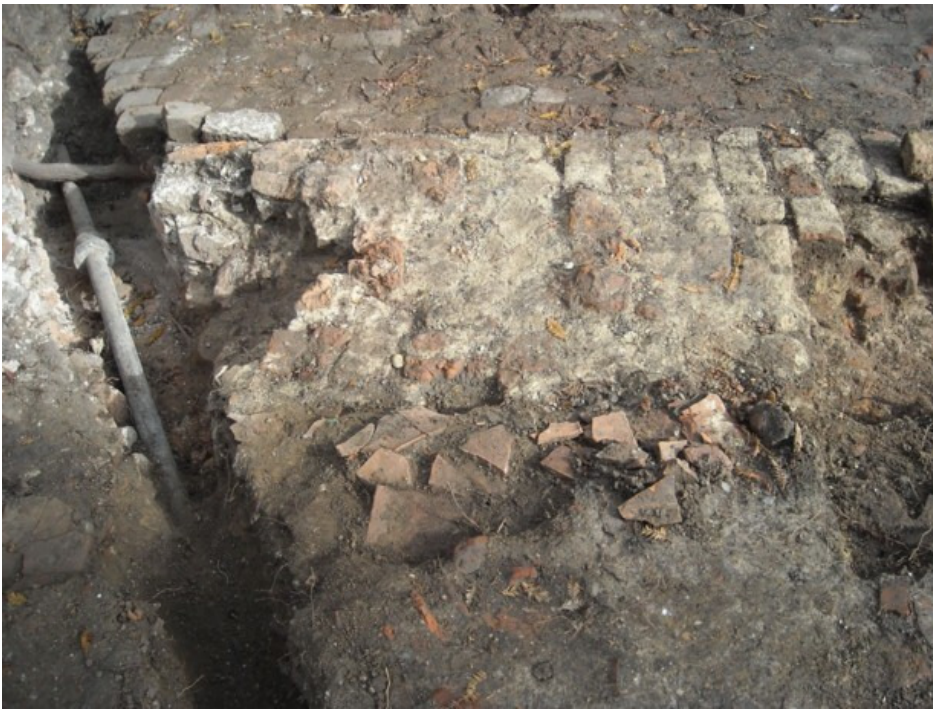
View looking north in Trench P, showing the cut with the water pipe, the wall of the Hall on the left, the west-east wall running across the centre, the brick floor in the background and the tile deposit in the foreground

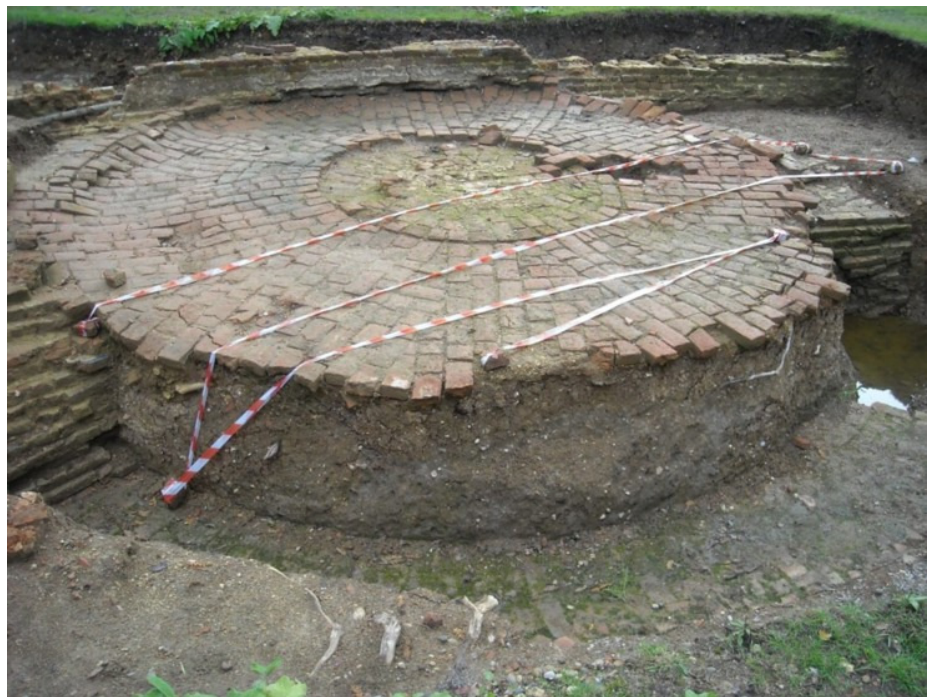
View looking east over Trench P, showing the insecure edge of the brick platform and the deposited layers in the vertical face of the robber cut.

the urgent need to stabilise the brick platform, which is endangered by erosion of the sides of the robber cut. This would then enable investigation of the infill deposits in the moat/ditch (visible as multiple layers of grey / brown in both faces of the cut), and the underlying structure of the brick platform and its central column.

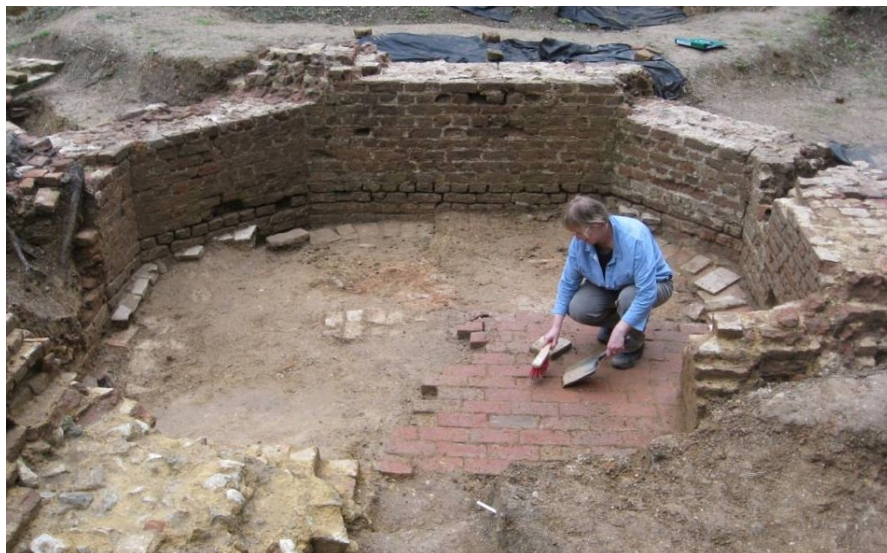
Cleaning the brick floor in the stair bay on the western side of the Hall

where one wall 'should' be was not particularly helpful, although clearance of what we assume to be demolition rubble revealed more of the remains of the brick floor which we first saw last year.

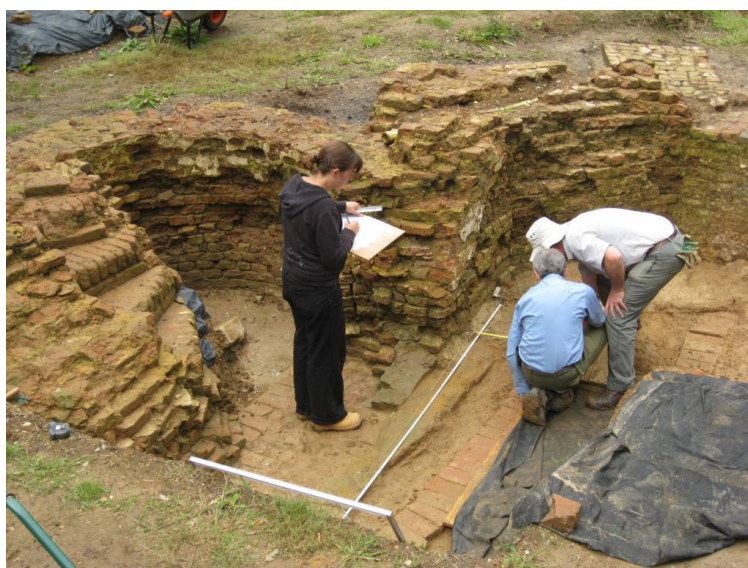
Planning the brick drains in the west end of the great hall

Removal of the clay backfill in the cellar of the great hall was more rewarding, however, as a number of brick drains were revealed, suggesting the floor must have been very damp.

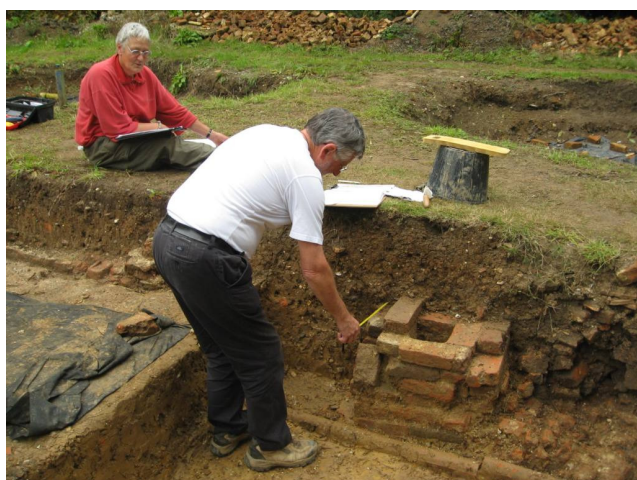
The brick socket or chute

Outside the footprint of the building, the plan had been to do a final check, record and backfill of a sondage previously dug around the site of the Rose Garden's central sundial, where an earlier north-south wall had been found. As it turned out, we will have to delay backfilling, as a mysterious brick structure came to light in the side of the trench. Not unlike a chimney or flue, it may have been a socket for a timber upright, or possibly a chute or downpipe for water.

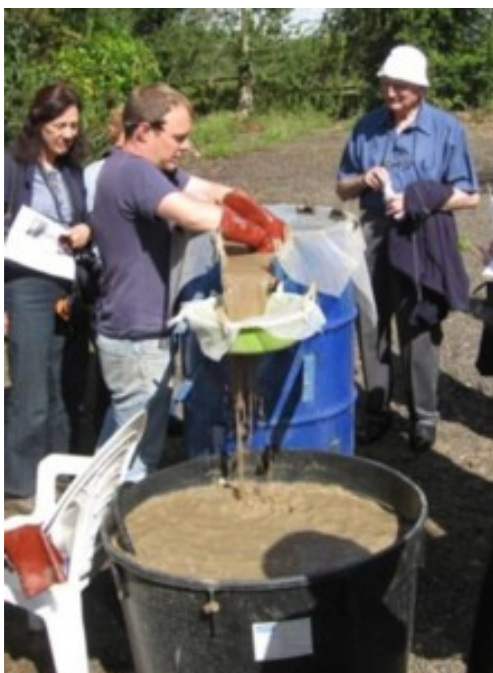
The flotation tank in action

Of particular interest to Mike, and everyone else this year, was the environmental flotation tank masterminded, constructed and operated by Nick Daines. This is used to wash and sieve samples of any deposits which might contain tiny seeds, shells or bones. One sample from Trench P was taken of the soil surrounding the bones of four medium sized birds, and processing in the flotation tank revealed a number of very small bone fragments.
