West Essex Archaeological Group Experience Weekend Summer 2025

Introduction

Copped Hall Trust Archaeological Project, Essex:

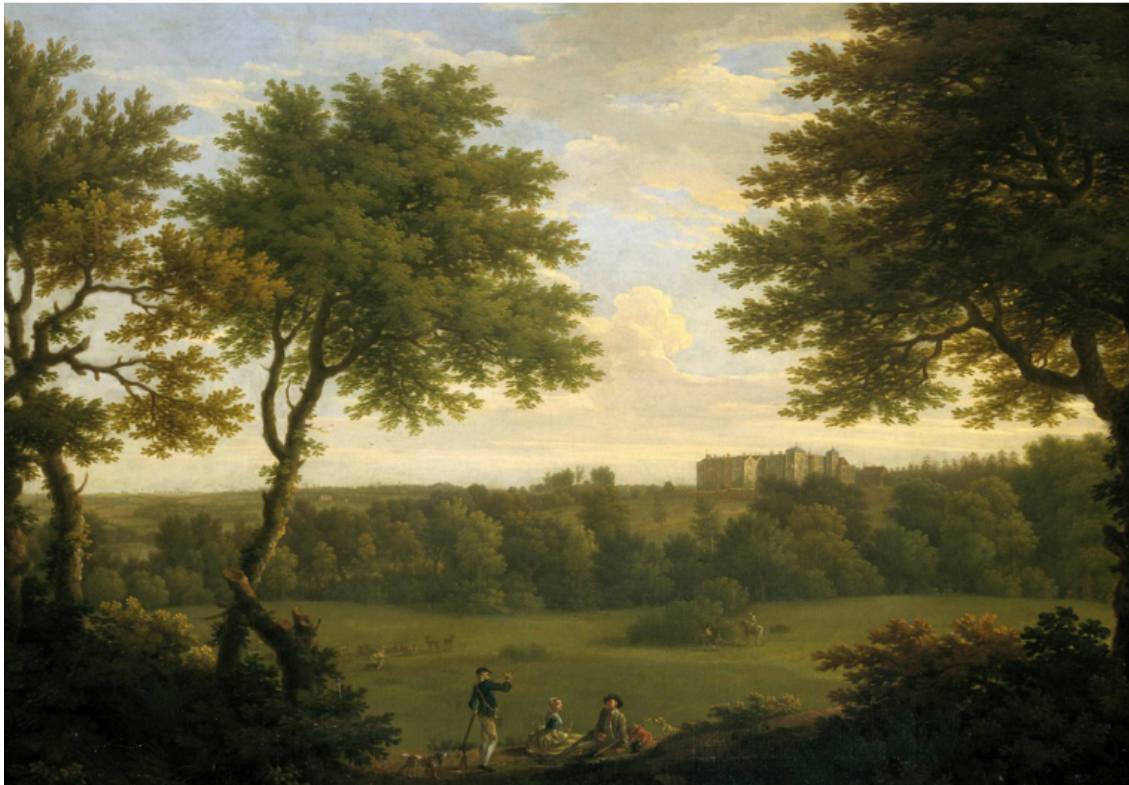
Fig. 1 - View of Copped Hall in Essex, from the Park - 1746 - George Lambert and Francis Hayman. Commissioned by John Conyers to record his inheritance and commemorate the Tudor House before he demolished it.
(Image courtesy if the Tate Britain)

An early drawing of Copped Hall, shows a row of roof gables. It would have originally been constructed as a timber framed building but would later have acquired tall brick chimneys. The external walls of the principal parts would probably have also been rebuilt of brick with corner buttresses. The mansion would have endured alterations and rebuilding over the centuries to keep pace with architectural fashions. In 1564 when Queen Elizabeth I gifted Copped Hall to Sir Thomas Heneage the buildings included a hall, great chamber, kitchen and service rooms, a court with a double gate, and a moat. It is likely that Heneage carried out major rebuilding work before receiving Elizabeth as a guest, either in July 1568 or in time for her second visit in 1578. A view of Copped Hall in its final form can be seen in M.J. Farmer's 1735 drawing (Fig. 2). This shows a house of three storeys: the south range with wings to east and west enclosing a courtyard, the north side comprising a single-storey loggia or covered colonnade.

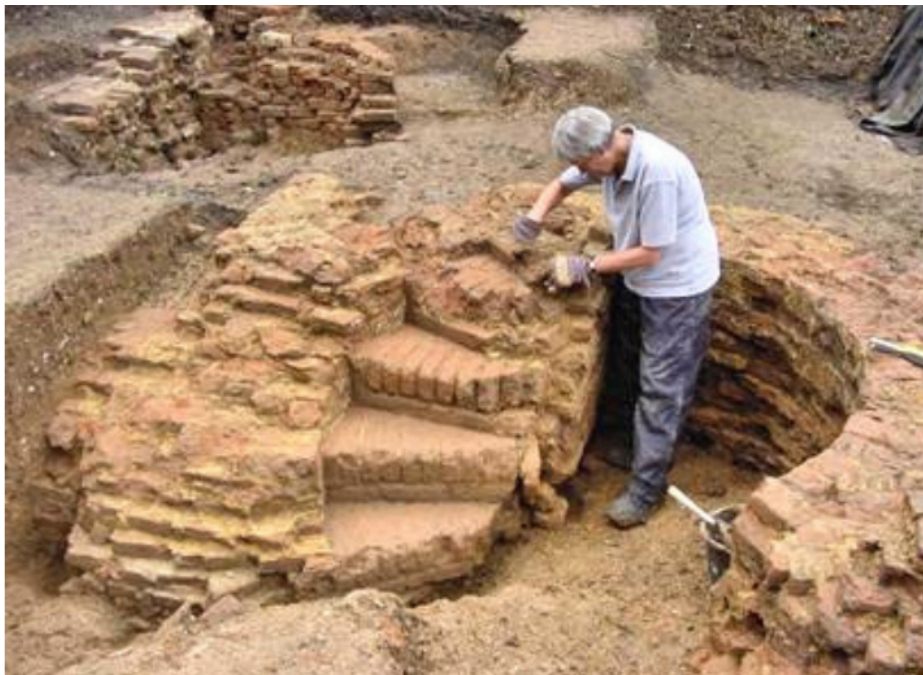
Fig. 5 - The spiral staircase (Trench G) being excavated; it does not match the Newdigate plan, and is believed to possibly pre-date the square stair tower at the south end of the plan.

In recent years WEAG have focussed on finding remains of the vast garden landscaping; to the south-east of the building footprint, successions of pebble paths, landscaping layers, and garden walls have been found. In the last couple of years we have investigated the slope between the existing upper and lower lawns, based on what appears to be a staircase structure in the 1735 Farmer drawing (Trench Y). This trench is still under investigation and most notably has produced large stone window mullions, likely recycled from the original house, that were used to support the stair treads.

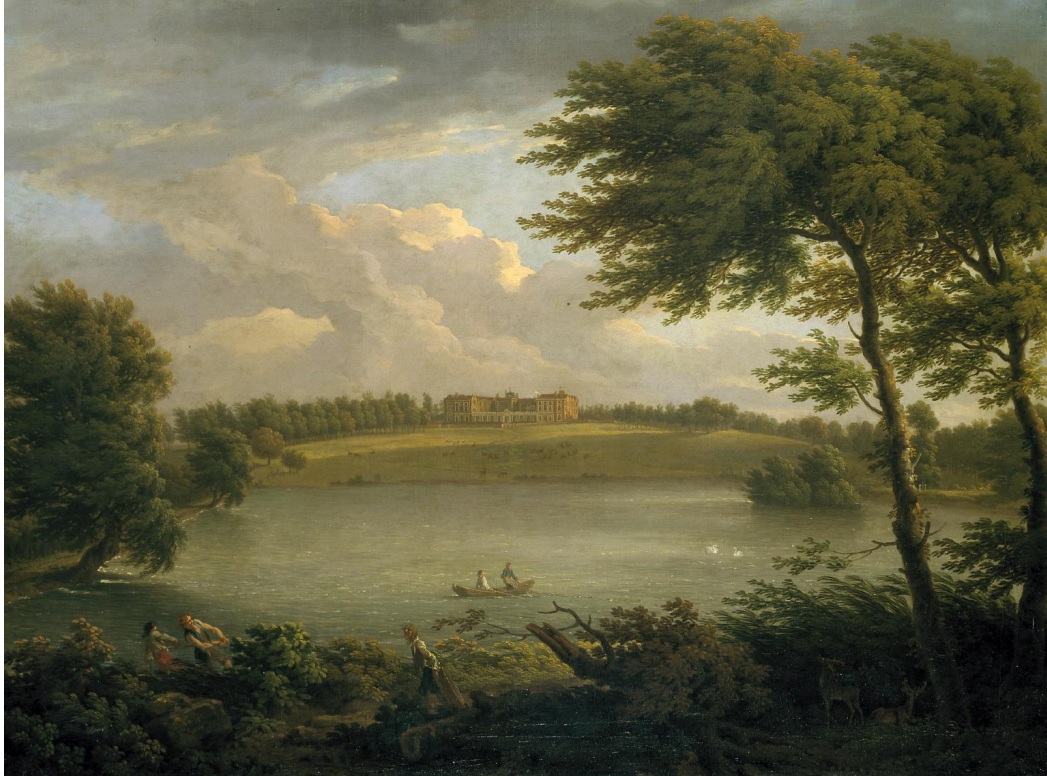
Fig. 8 - View of Copped Hall, from across the lake - 1746 - G. Lambert and F. Hayman. Commissioned by John Conyers to record his inheritance and commemorate the Tudor House before he demolished it. (Image courtesy if the Tate Britain)

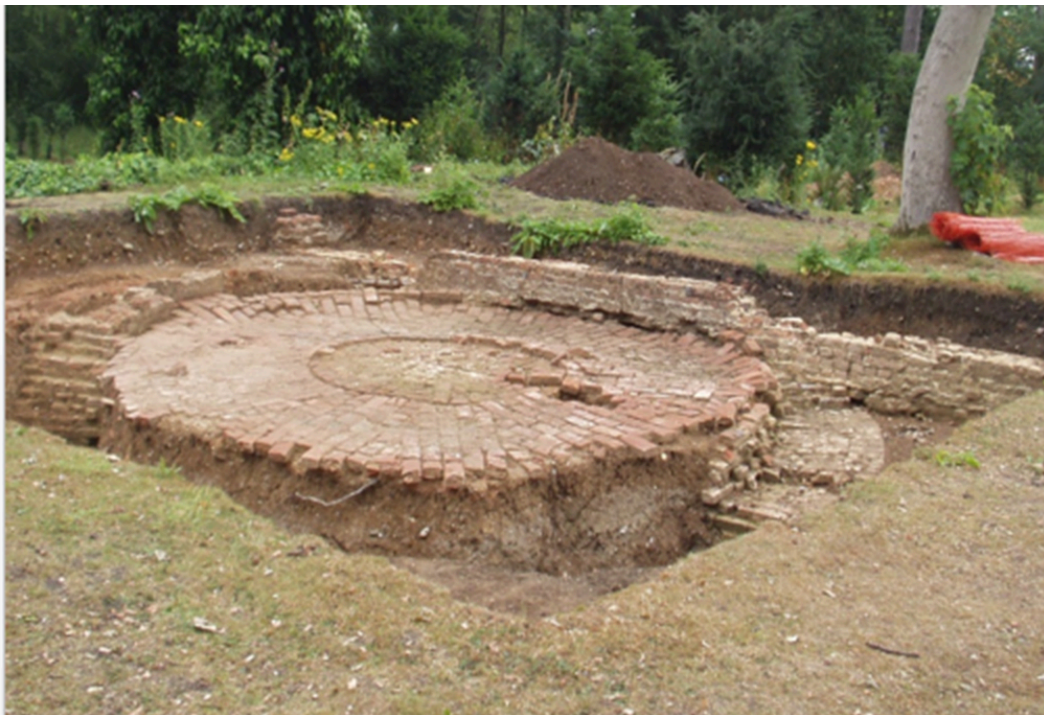
Fig . 9 - Circular feature in Trench P, now closed. Believed to be the remains of a Tudor Dovecote

In 2007 a ground-penetrating radar survey just south of the original house revealed a large round feature (Trench P - now closed). Excavation uncovered a circular brick platform with substantial foundations. It is thought that the structure was a dovecote (**Fig. 9**).
